<b>Tracker Number</b>	<b>T58449</b>
<b>Pump Type</b>	<b>Labour 14DZTM</b>
<b>Serial Number</b>	<b>PT27631/2</b>
<b>Site Asset Number</b>	<b>P384</b>
<b>Site Location</b>	<b>To be confirmed</b>
<b>Atex Required</b>	<b>Unknown-please confirm</b>

**Inspection Report**

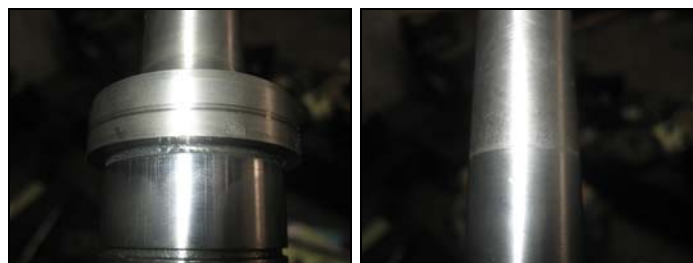
**Worn locations on shaft**

- The wet end of the pump is in reasonable condition with only light wear found
- The mechanical seal appears worn and was contaminated with product.
- The shaft is worn on the mechanical seal NDE
- lip seal locations and will require metal spraying
- Both bearings appeared to be suffering from general operating wear

- Metal spray shaft on NDE lip seal and mechanical seal location
- Sleeve DE bearing housing

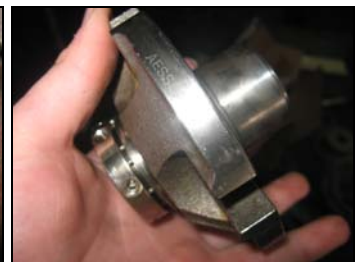
**Mechanical seal**

No obvious reason for failure could be attained other than possible seal leakage  
The seal is to be sent to AES seals for analysis

- 2 Bearings – Free issue
- 2 Lip Seals - Free issue
- 1 Casing Gasket Free issue
- 1 Mechanical seal-Free issue
- 2 Bearing housing gaskets
- 2 Perspex Guards
- 1 Woodruff key
