T58127

Pump Ref: 2BB 9670

Inspection Report

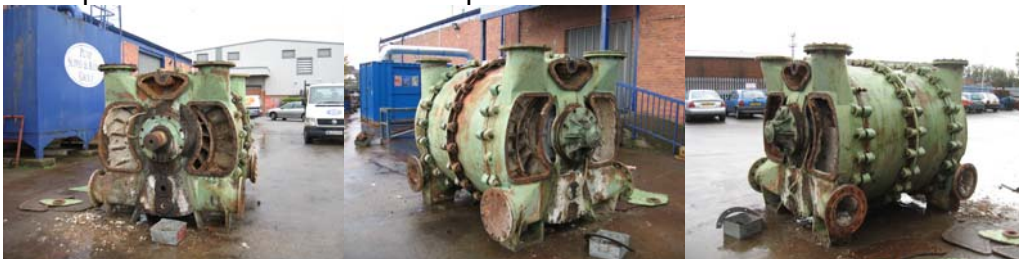
Unit as received

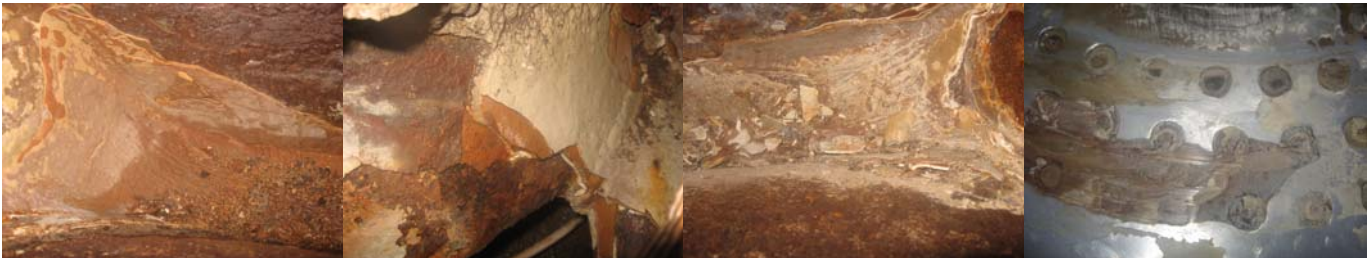
- On inspection of all internals a heavy build up of lime scale was present. This in areas was 10-15mm thick. This was apparent on the rotor vanes and internals of the headers.
- Both headers anti cavitation holes were completely blocked with this scale build up.
- The flap valves were missing – PTFE part
- Both bearings were inspected and general operating wear was found. All bearings were well lubricated and still intact
- A large amount of the fastenings will need to be replaced as they are worn and corroded
- A number of the body clamps have sheared and will need replacing.
- One lantern ring is damaged

Scale build up in header internals, Rotor and anti cavitation holes

To minimise the risk of similar build up of scale in the future we would propose to coat both rotor and internals of the headers with **Belzona 1341 Super glide**. This product will reduce the level of scale build up by improving the efficiency of the fluid handling systems and protecting metals from the effects of erosion/corrosion. This will also improve the efficiency of the unit by reducing viscous drag. We will have to advise that the chemical cleaning which is currently in operation at your site will not be suitable for this product if left submerged for the 3-6 hours. Based on the information given by yourselves a flush through with the chemical followed by a water flush will be acceptable. We would advise if possible the unit is monitored without flushing for a limited period to inspect the level of build up and requirement for flushing

Prior to coating, the header internals and rotor will be grit blasted to SA 2 ½ @ 75microns. The components will then be chemically cleaned by pressure washing and left to breathe. This process will be repeated until acceptable levels are obtained. The components will then be final grit blasted to SA 2 ½ @ 75 microns prior to coating.

The coating will be applied in two coats of different colours @ 250 microns per coat. This is to ensure that all the base material is coated and future wear patterns are visible.

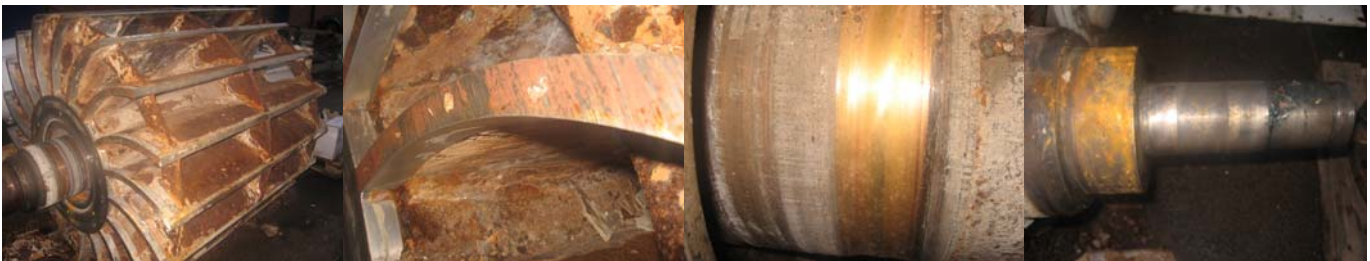
- The stainless steel support rings which been added to the rotor are on the whole still in good condition. The running faces of the rotor however are heavily scored due to contacting the header end plate plates during operation.
- The gland sleeves are heavily scored
- The bearing locations are worn and scored

Rotor Scoring to rotor face Worn packing sleeve Worn bearing diameters
Body 1 (smaller section)

1. Machine rotor to a length of 1344mm
2. Remove existing Bronze sleeves
3. Manufacture and fit new bronze sleeves
4. Chase all threads
5. Polish all shaft diameters
6. Spiral weld both bearing location. Lloyds and DMV approved
7. Dynamically balance rotor assy to ISO G6.3

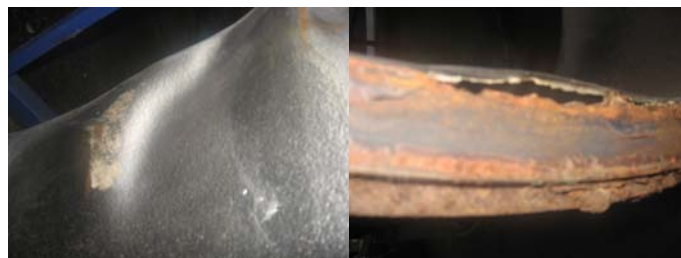
The stainless steel lining has started to buckle and lift from the base metal at one end. This lining is no longer in a repairable condition

Buckling and lifting of body

1. Cut existing stainless steel lining from body
2. Roll new 316 3mm stainless piece and weld and bolt into body using counter sunk screws. - This process will have to take place after the machining of the rotor
3. Stainless steel weld counter sunk screws and machine
4. Machine body to 657mm

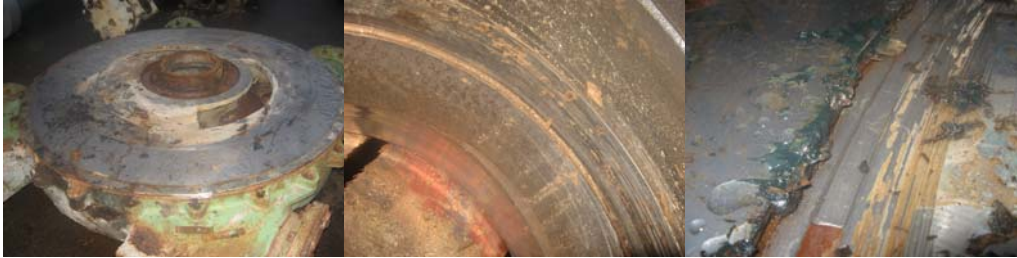
Header assy

Both header assembly end plate liners are no longer fit for use
Heavy scoring and fracturing is apparent and in areas the cast iron material has started show through.

Scoring and fracturing

1. Remove existing stainless steel end plates
2. Machine end plate location
3. Manufacture new 316 stainless steel end plates
4. Bolt plate to header assembly using counter sunk screws
5. Stainless weld counter sunk screw
6. Final machine so foot to plate distance is 257mm
