Tracker No: T57476

Pump Ref: Stothert and Pitt Size 235

Condition Report

Inspection Report

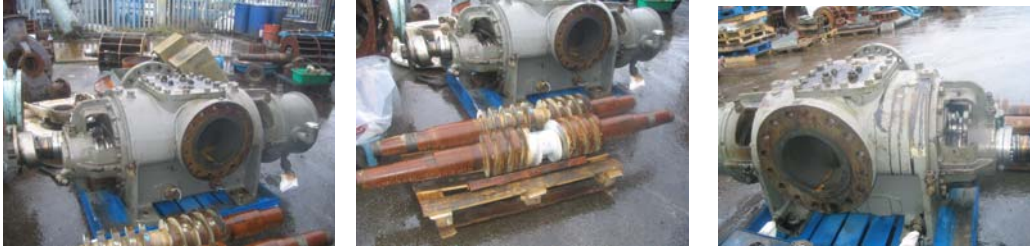
Pump as received
