Fluid Coupling Repair

Unit: Fluid Coupling

Industry: Power

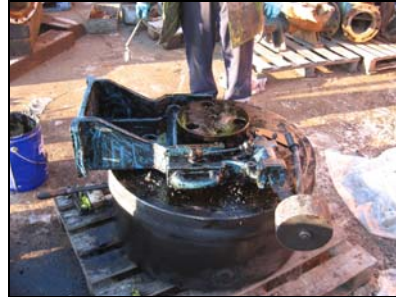
Unit as received

The unit prior to disassembly was imaged and booked on to our database which allocates a unique internal repair and tracker number. The unit was then dismantled, pressure cleaned and shot blasted and inspected and the following was found

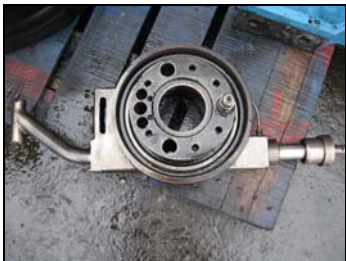
- The main shaft remained in a serviceable condition requiring a general clean and polish.
- The scoop control assembly remained in a serviceable condition requiring a general clean and polish. It has been actuated by hand and controls easily.

Scoop control assy

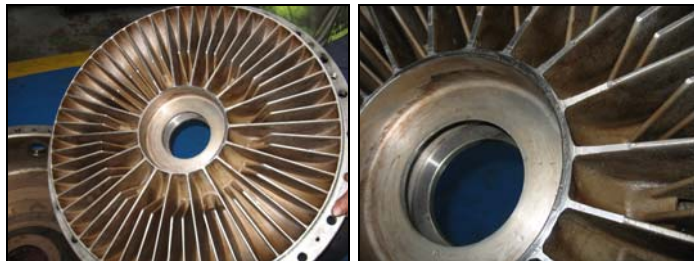
- The impeller and runner showed signs of a mechanical rub having taken place at some time; apart from this they both looked fit for further service.
- The reservoir casing appeared to be in good condition, machining tolerances and concentricity were brought back to standard.

Impeller/runner assy + Rub Marks

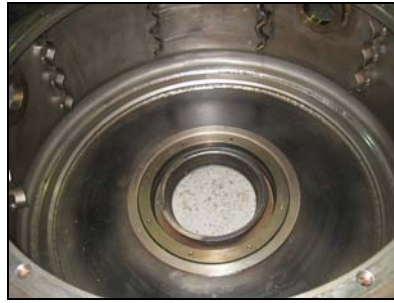
Casing valve seat area

- All damaged or worn fasteners were replaced including the critical fastenings which hold the valve seats to the casing as they needed to be leak proof.

- 1 x Corrective Machining to spigots
- 1 x Baffle Plate weld
- 3 x Valves, as specified over
- 3 x Valve Seats, as specified over

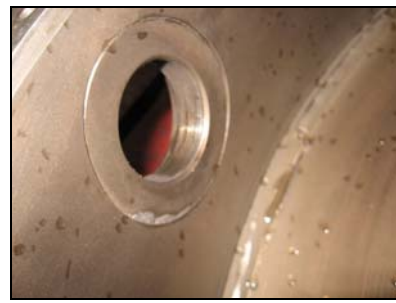
- 3 x valves and valve seats appeared in good condition and were cleaned, reset and a general overhaul was carried out to each valve.
- 2 x Bearings which were specific for the assembly were replaced, together with all seals, O-Rings and gaskets. The bearing ring had worn due to impact at some time previous.

Bearing Hsg Rub

- 1 x Set Bearings
- 1 x Seal Kit
- 1 x Set Fasteners as required

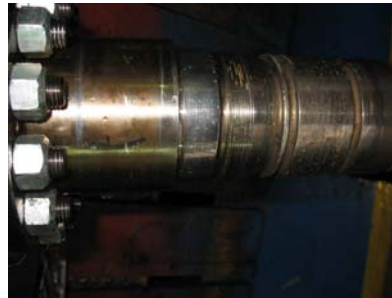
Shaft condition

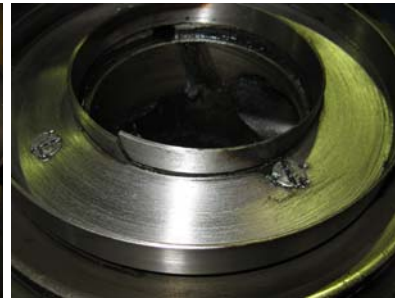
- A critical baffle plate had fractured due to impact damage, this was welded

Baffle plate fractured
