**Pump:- Weir 18"x14" Gland Packed
Stock**

Industry:- Paper Mill

Pumped Media:- Paper

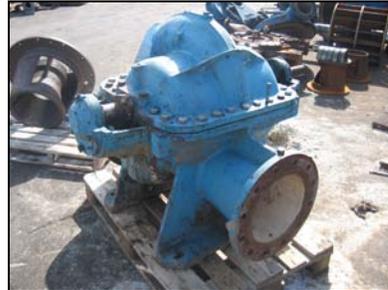
Unit as received

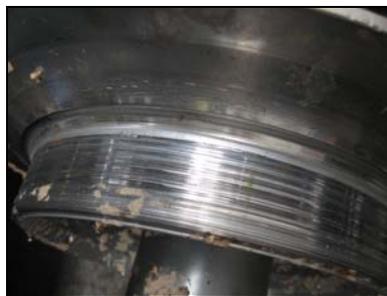
- The shaft is generally in a good condition but both shaft sleeves are deeply grooved due to gland packing abrasion.
- Both will need replacing after being pressed from the shaft. All sleeve make up bushes are in reasonable condition and can be re-used. The locking nuts need replacing.
- The impeller itself is in good condition but its wear rings are deeply grooved due to the abrasive action of the stock. Both wear ring areas will need to be machined away, re-built and the clearance brought back to standard.

Scored impeller neck

- The rotating assembly was brought back to standard with the impeller wear ring areas adjusted to tolerance. New bearings were fitted. All gland packing rings were replaced and the lantern rings cleaned of existing grime.

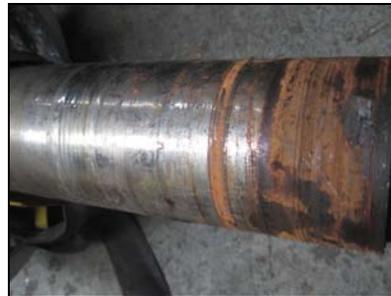
Scored Sleeves

- The rotating element was dynamically balance checked and adjusted if outside tolerance.
- Both shaft sleeves were repaired with Belzona 1131 which has a unique micro-porous structure to trap and hold lubricating oil and minimize friction and wear on start up.

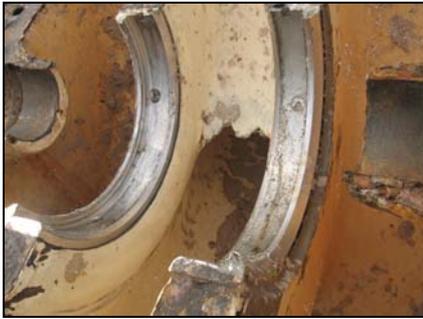
- The bottom pump casing has been previously coated. The area around the cutwater is worn back and this ideally needs bringing back to a standard profile in order to maintain pump efficiency. The two saddles where the casing wear rings locate are in good condition. The body surface contour has lost sections of its previous coating. Both wear rings, although in a good condition, are worn on the bore. The excessive clearance will be adjusted back to standard when the impeller wear rings are refurbished.
- The top casing likewise has been coated and has lost sections of its previous coating during service. The two saddles where the casing wear rings locate are in good condition."

Top half saddle

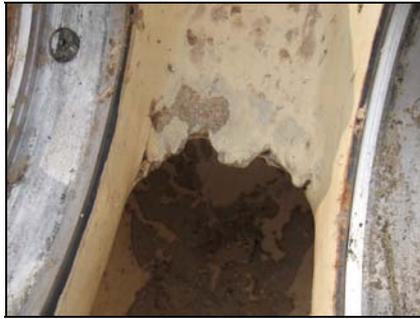
Cutwater wear

- The body was grit blasted to SA 2 ½ @75 microns to remove suspect coating, and achieve correct surface profile and cleanliness requirements. The internal surface contours were then coated in a two coat system of 1341 super glide due to the customer's requirement to improve efficiency and improve power consumption.

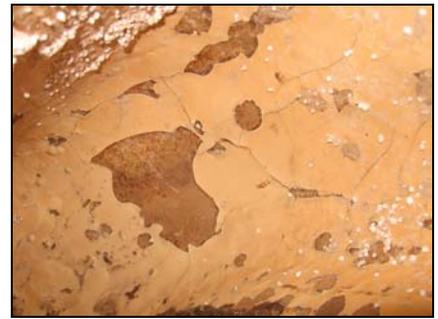
Flaking coating from previous repair

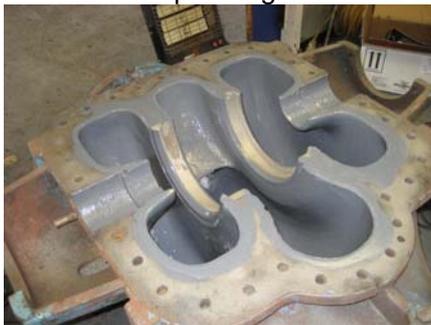
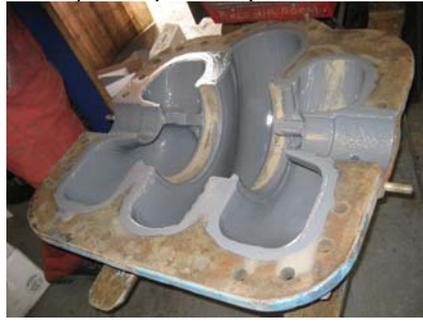
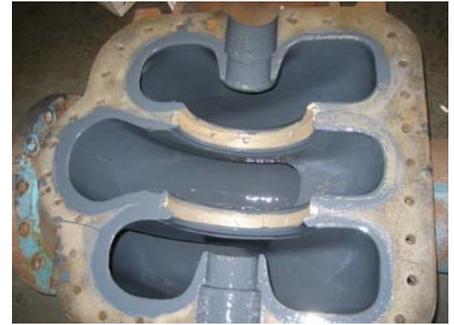
Casings coated with Belzona 1341 efficiency coating

- The unique hydrophobic nature of the Belzona 1341 system makes water simply roll off. Wear by abrasion is minimized by its encapsulated blend of lubricating and abrasion resistant fillers. When applied to fluid flow equipment, Belzona 1341 can reduce power consumption, increase efficiency; lower operating costs and improve hydro dynamic performance

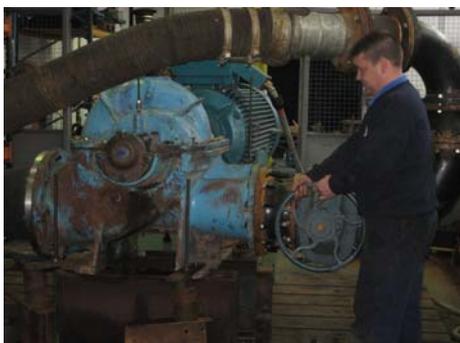
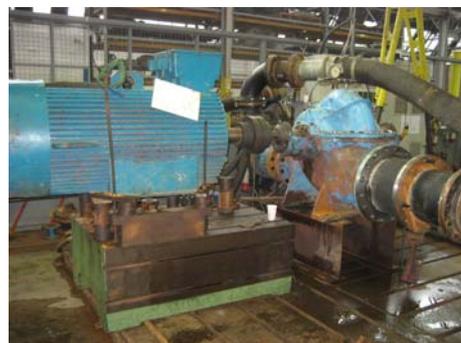
Unit being performance tested in our workshop

The unit was then rebuilt with the following spares 2 Bearings . 2 Gland packing sets. 1 Casing Gasket .2 Throwers. 2 Sleeve O-Rings.4 Locknuts On completion of rebuild the unit was installed on to our dedicated test facility and performance tested to OEM curve
