Pump: Metso Slurry

Industry: Power

Medium: Slurry/Fly Ash Product

Our Coating Centre has recently undertaken a job to rebuild a Metso Slurry Pump for a major Scottish Power Site. Once the pump unit was stripped to component form, the main areas of damage were the suction impeller and the volute casing showing severe erosion to casing.

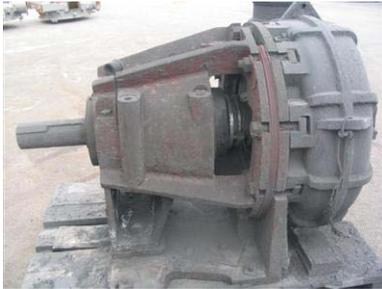
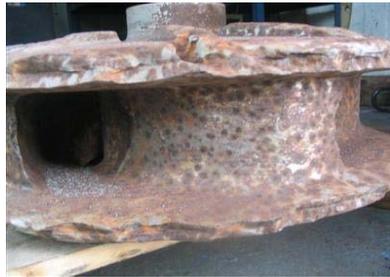
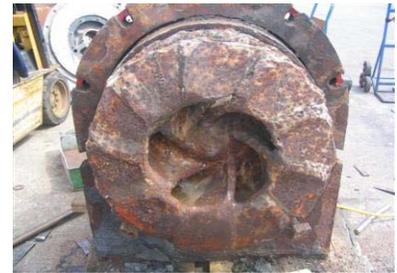
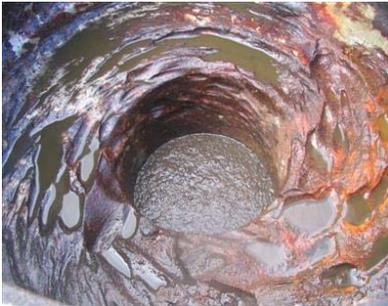
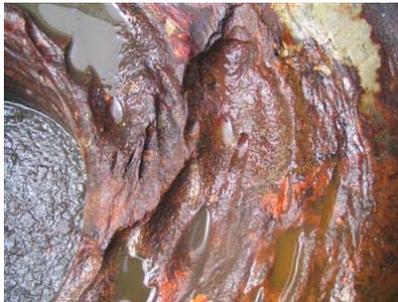
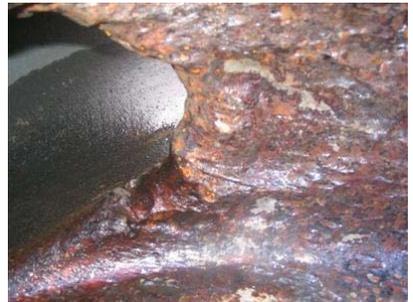
The pump unit is used for pumping slurry/fly ash product at the Power Station which is highly abrasive. The worn pump components are in excess of 500 Brinell hardness but still eroded.

The impeller had approximately 10-15mm missing from the leading edge and the volute had cavities approximately 20mm depth.

The components were rebuilt with Belzona 1121 Super XL metal back to original OEM profile then machined with diamond cutting tips

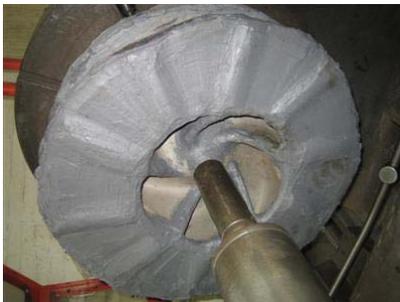
Machine Outer Edge

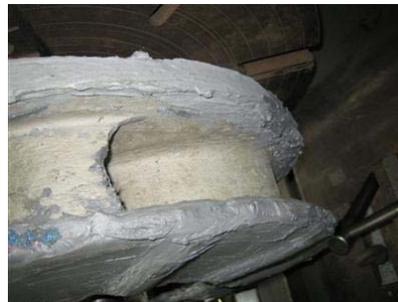
Rebuild Outer Edge

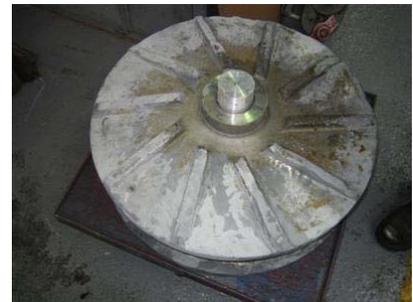
Rebuild Back Vanes

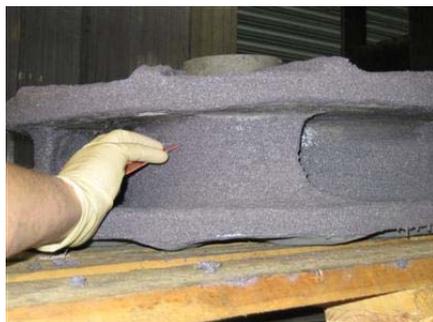
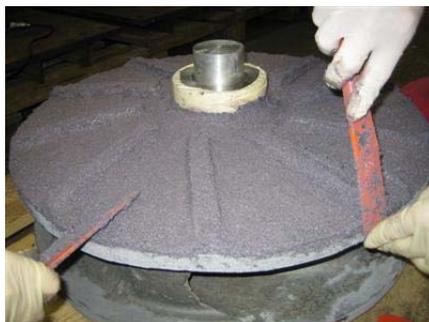
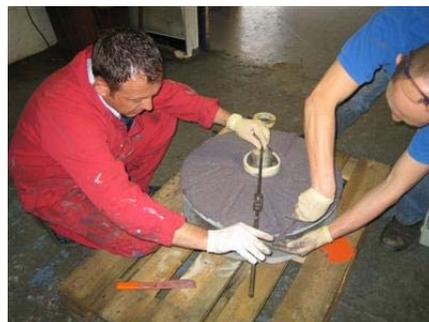
Re-build Impeller with Belzona 1121 Super XL Material

The impeller and volute case were then coated with 3mm to 6mm in areas with Belzona 1812 material which is a highly specialised composite combining extremely hard closely packing abrasion resistant materials in a polymeric binder to resist future abrasive attack.

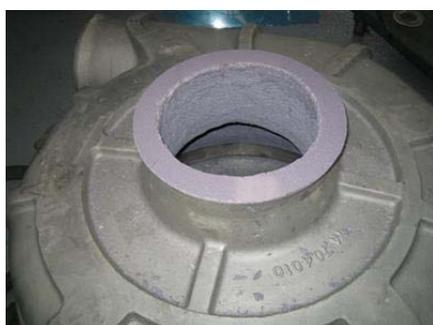
Rebuild Flange Face

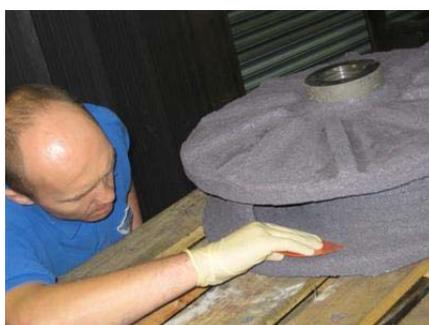
Rebuild Impeller Blade

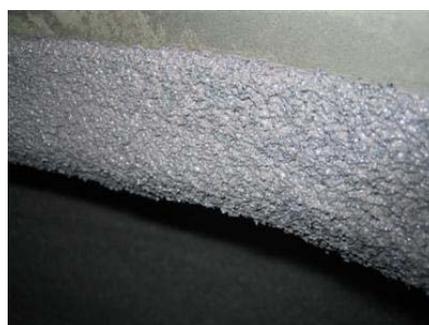
1812 Surface Profile

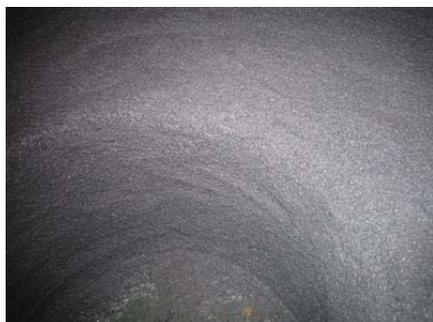
Inlet Port Coating

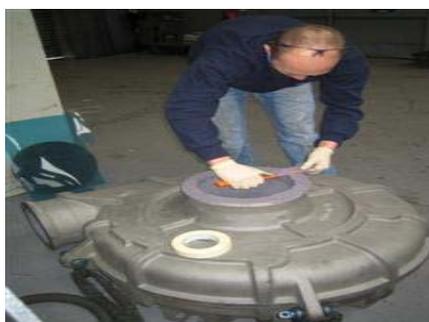
Rebuild Inlet Flange

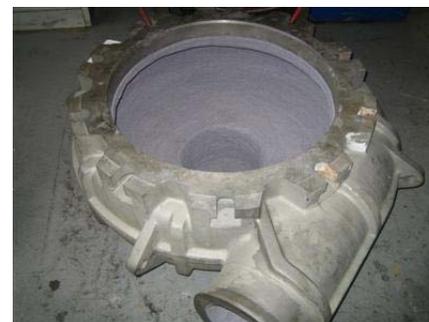
Standard of 1812 Coating
