**BELZONA[®] REPAIRS/PROTECTS
LP STEAM DIAPHRAGM**

Power Plant - North Carolina, USA

Low Pressure Steam Turbine Diaphragm

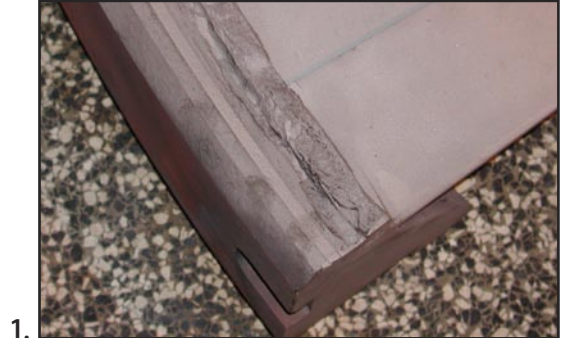
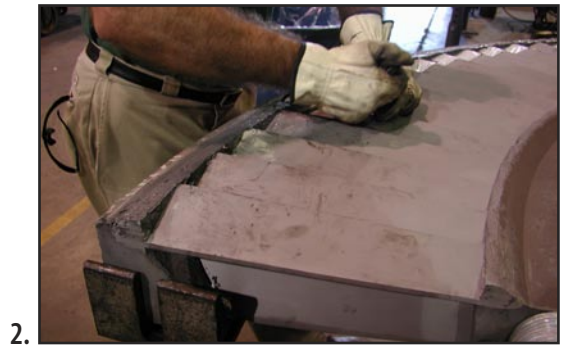
1. /2. Erosion damage is evident.
3. Belzona[®] 1111 (Super Metal) in place.
4. Completed application.
