BELZONA® REBUILDS AND PROTECTS VANES

Water plant, Egypt

Two water pump impellers

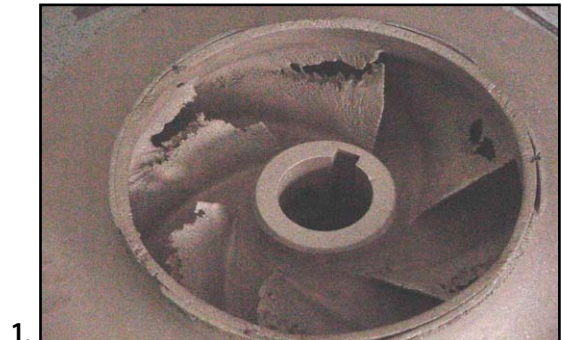
Vaness of the impellers were severely cavitated.

1. The cavitated vanes of the impeller.
2. Preparing to rebuild the lost edges.
3. Rebuilding the vanes.
4. Vanes were rebuilt and coated.
