BELZONA® REPAIRS WASTEWATER PUMPS

Large wastewater station, Egypt

Sulzer wastewater pumps (Five)

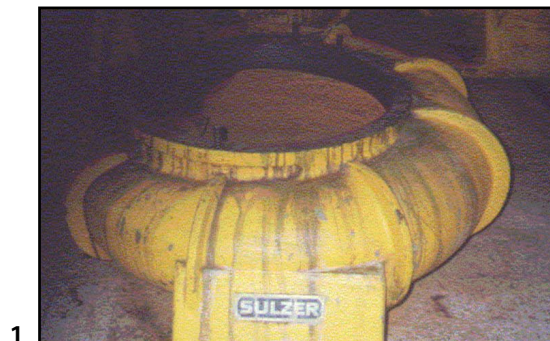
Corroded diffuser, casings and impellers leading to low efficiency of the pumps.

1. Corroded casings.
2. Corroded diffuser.
3. Diffuser was coated.
4. Impeller coating completed.
