Belzona® 2141 protects Francis Runners from Cavitation Damage

Hydroelectric plant (Ontario, Canada)

Twin 914mm (36") Francis Turbine Runners operating with 13m head and constructed in 1945.

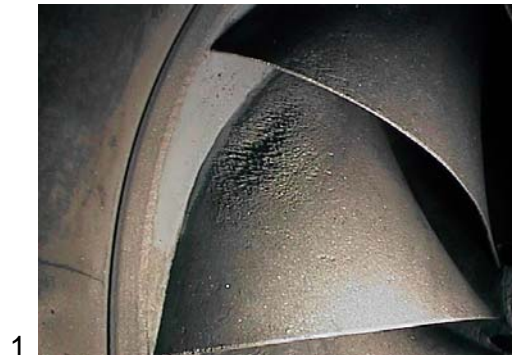
Cavitation had caused erosion of the parent metal and loss of performance of the turbine. Belzona® 1341 and 1421 had been applied in 1998 but had suffered erosion in this aggressive environment.

1. Cavitation damage
2. Belzona® 2141 after application
3. Belzona® 2141 after 34 months
4. Belzona® 1341 (left) and 1421® (right) after 36 months service

Following gritblasting the Belzona® 2141 was applied by hand to one of the turbines, using the Belzona® 2941 conditioner to provide optimum adhesion to the substrate,

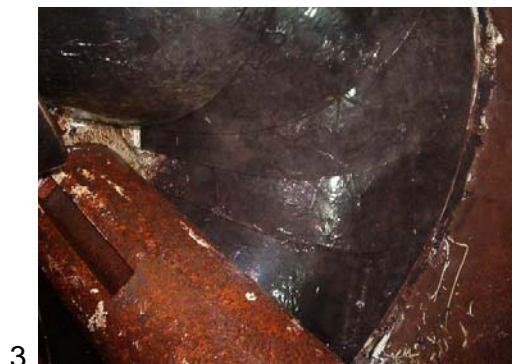
Inspection of the Belzona 2141® in 2002 showed no damage – further inspection after 34 months showed no sign of damage to the coating
