## BELZONA® RENEWS DAMAGED LINING

Refinery in North Texas, U.S.A.

Fiberglass tank used to store spent sulfuric acid.

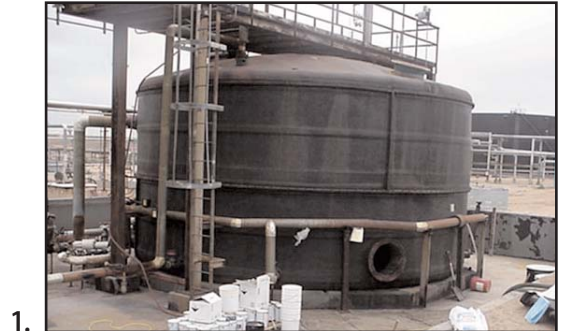
1. Outside view of the sulfuric acid holding tank.
2. Close-up view of the FRP substrate.
3. Application of the first coat commences.
4. The second coat is applied.

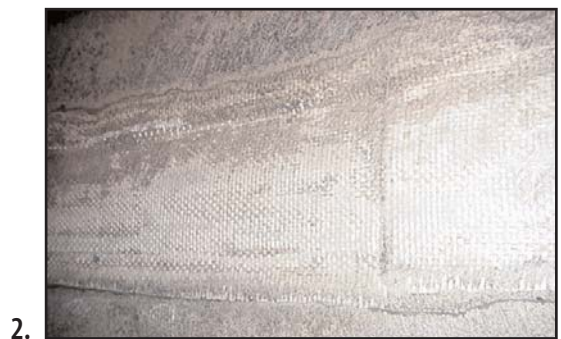
Dilute sulfuric acid eventually attacked the fiberglass surface and had the gel-coat completely eaten away in sections. The first layer of cloth was exposed in 50% of the internal tank surface.

All exposed glass fiber ends were shaved off. The internal tank surface was blasted and coated with two coats of Belzona® 5811. In August 2003, the refinery reported it had experienced perfect performance with coating.
