## DEIONIZER COATED WITH BELZONA<sup>®</sup>

Medicine factory in Egypt

Deionizer in the companys water treatment plant.

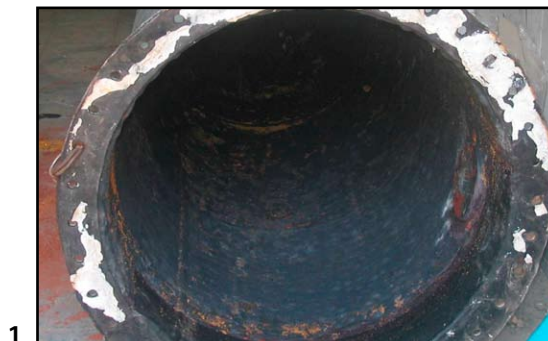
1. General view of the deionizer.
2. The failed rubber lining.
3. Deionizer from inside after coating.
4. Application completed.

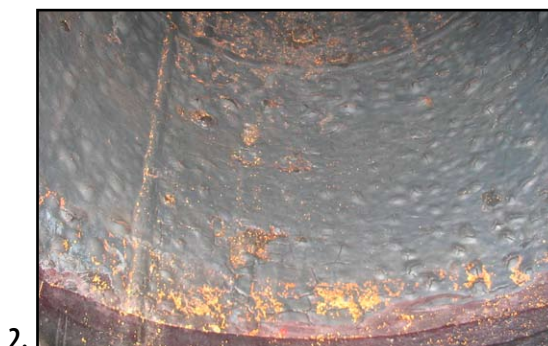
Failure of rubber lining due to aging and chemical attack.

Rubber lining was removed then Belzona<sup>®</sup> 5811 was applied to provide long term protection to the deionizer. The deionizer was inspected after a year and found to be in perfect condition. More deionizers were then coated.
