## Belzona 1321 Ceramic S

**Pump: Rotary Drum**

**Industry: Tannery**

**Medium: Oil /Leather**

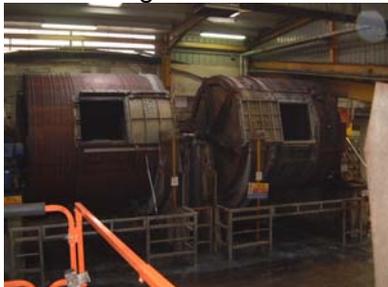
**Drum**

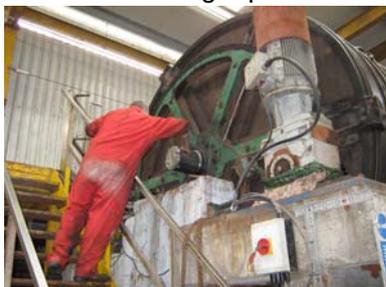
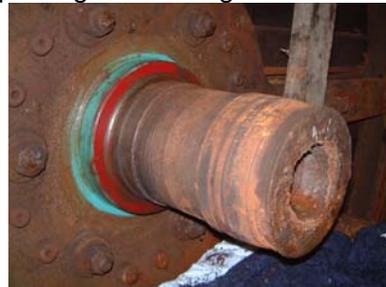
The bearing location had worn due to the bearing taper sleeve spinning and cutting in to the shaft

**Wear to shaft**

We advised that the shaft could be repaired by using Belzona polymeric

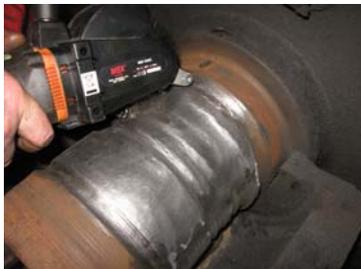
A profile was then cut into the shaft using the Belzona MBX tool which will leave a surface profile of 50 microns

**MBX tool cutting profile**

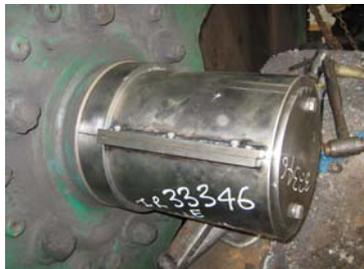
Prior to our Belzona technicians attending site a split mould was fabricated. The internal bore was machined to the required size of the bearing sleeve diameter

**Manufactured mould set in to position**

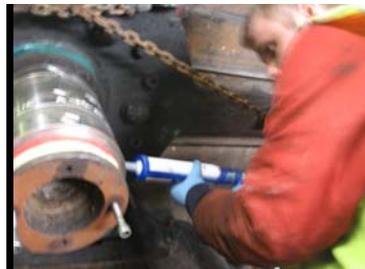
**Belzona being injected**

The mould was then treated with release agent and fitted to the shaft. Once all setting and shimming had been carried out Belzona 1321 ceramic s was then injected into the mould. Once product escaped through escape holes on the opposite side the void had been filled

The shaft was then left to cure. Once cured the mould was removed leaving the bearing sleeve location repaired
