## BELZONA, THE ALTERNATIVE TO WELDING IN DIFFICULT SITUATIONS

Vegetable Oil Processor - Liverpool, UK

Five-meter diameter storage tank - carbon steel construction

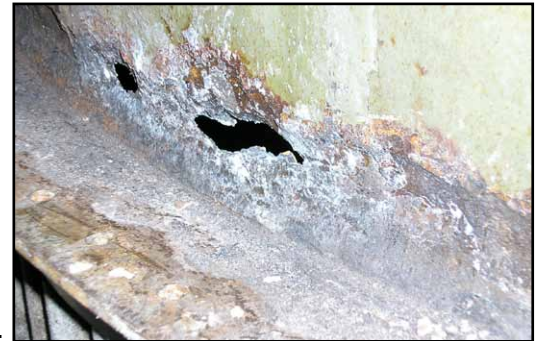
The tank was experiencing classic Corrosion Under Insulation caused by water ingress that was sitting on the lagging bands around the tank and soaking through the lagging. The problem was further exacerbated by the elevated temperature of the tank. Problem made still worse by the lining material being highly volatile requiring a Nitrogen shroud before and during any potential welding operations.

1. Scenic view of the tank farm.
2. Damage to tank wall.
3. The Belzona repair. After surface preparation to achieve profile the profiled plates were bonded in place with a fillet of Belzona material between them to allow excess water to run off.
4. Close up of repair area.
