## BELZONA PROVIDES CAVITATION PROTECTION TO PUMP IMPELLER

Chemical plant, Italy

Coating for new impeller

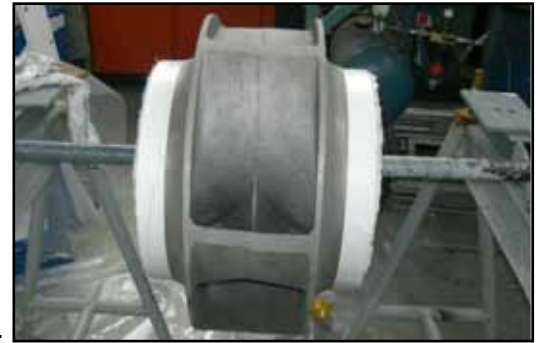
1. Blasted Surface
2. Coated with Belzona® 1341
3. First coat of Belzona® 2141 (black) applied
4. Application completed with a second coat of Belzona® 2141 (green)
