BELZONA® REPAIRS DEWATERING CENTRIFUGE

Wastewater treatment plant in California U.S.A.

Worn flights on a Humboldt Dewatering Centrifuge.

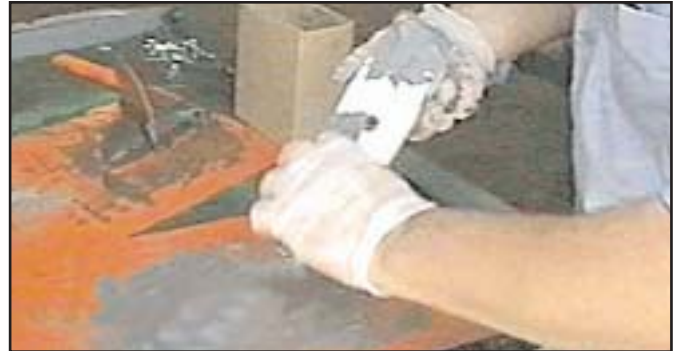
1. Applying Belzona® 1111 (Super Metal) to tiles.
2. Fastening tiles to the flights.
3. Tiles installed along circumference of flights.
4. Belzona® 1811 applied over bolts and inlet port areas.

The application was carried out in accordance with Belzona Know-How System Leaflet SHM-7. In-house staff prepared the flights by grinding and using Belzona® 1111 to grout and back tiles onto the flight blades. Following the initial cure, Belzona® 1811 was used to further protect the blades around the feed ports which suffered from the highest amount of abrasion along with the recessed bolts that held the tiles.
