## **BELZONA® REPAIRS THIS VACUUM PUMP AND INCREASES ITS EFFICIENCY**

Fossil fuel power station in Australia

Water ring vacuum pump for main condenser.

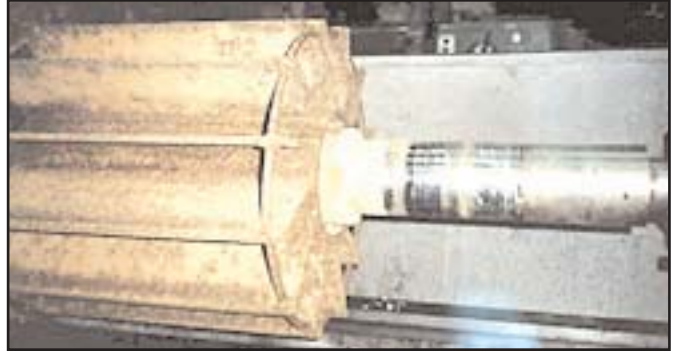
Corrosion damage to the end covers and impeller, as well as heavy souring of the gland packing locations on the impeller shaft caused insufficient vacuum pumping and loss of pressure.

1. Scored area of the shaft.
2. Undercoat area of the damaged shaft.
3. Application of Belzona® 1131.
4. The rebuilt shaft after machining of Belzona® 1131.
