BELZONA® PROTECTS COAL DIRECTOR

Coal-fired Power Plant - Ontario, Canada

Coal director for pulverizer

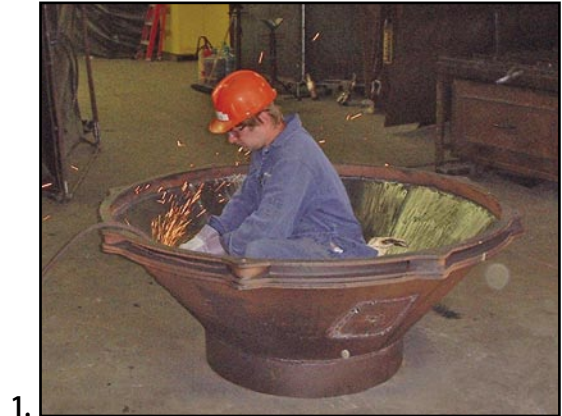
1. Surface preparation.
2. Product was kept warm with the help of this steam pipe.
3. Completed application.

New steel was put in place. Steel was hand prepared and Belzona® 1812 material was put down with 1/8" thickness. This Belzona system provides excellent abrasion resistance, while ensuring the coal moves as required.
