## BELZONA® EXTENDS THE LIFE OF ID FANS

Pulp and Paper Operation - Port Alberni, British Columbia, Canada

ID Fan housing

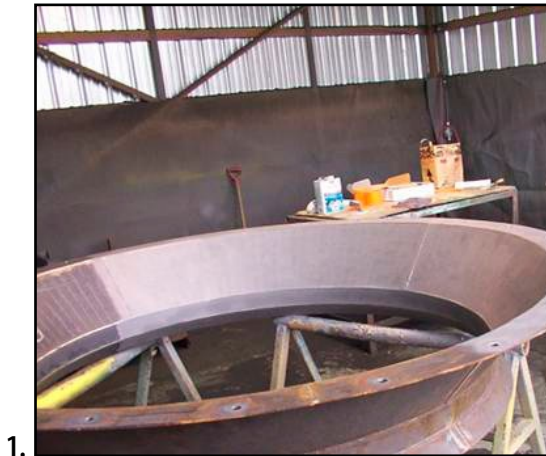
1. Two new housings awaiting grit blasting.
2. Application of Belzona® 1812 in progress.
3. Application to first housing complete with second partially completed.

The ID fan housing would wear away necessitating replacement every two years at best.

An initial test on an original badly eroded unit proved the cost benefits of the application to the customer. With the Belzona product acting as a sacrificial wear surface minimal metal loss was recorded during the 12 month test period.
