Tracker No: T58491
Pump Ref: AFP25HDEX

Your Ref: Furness Vale

Condition Report

Inspection Report

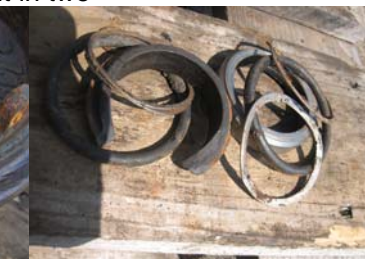
- Heavy wear is apparent to the impeller vanes, back face and outer diameter. A new impeller is required
- The volute casing is worn where the Impeller outer diameter runs. Also heavy wear is apparent where the bottom plate locates. The volute requires replacing
- The bottom plate assembly has worn into two parts and is now beyond repair.
- The mechanical seals are worn and need replacing
- The adapter plate and adjusters are worn and need to be replaced
- The shaft is worn in certain areas and will need to be metal sprayed
- The motor was electrically tested and found to have a fault down to earth. The motor was then dried and tested and found to be satisfactory. The bearings will however require replacing

Wear to impller OD and back face

Due to the level of wear found we deem the unit beyond economical repair

We propose to supply a new unit superseded unit which will fit into existing application

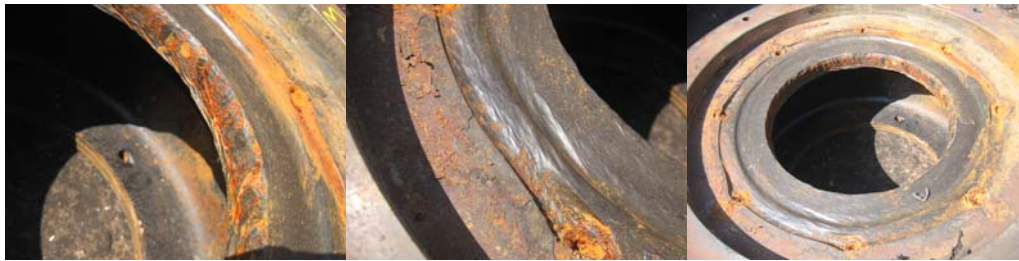
Wear to volute casing
